# In-Situ Immobilization and Bioremediation of PFAS

Larry Kinsman | ORIN Technologies in conjunction with Miller

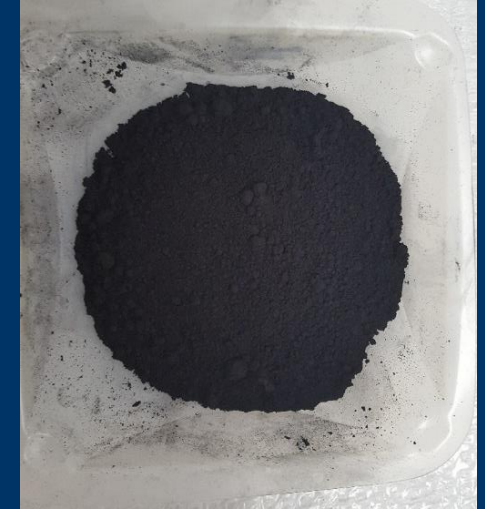
Milled BAM.  
Inject in slurry.

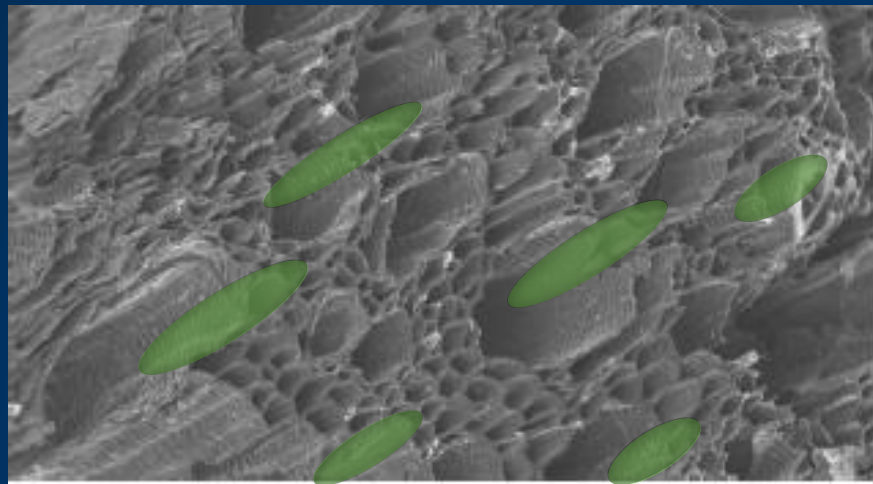
Environmental scanning electron microscope (ESEM) image of micro-pore structures

- Surface area = 1,125 m<sup>2</sup>/g
- High absorption capacity
- Prevents exterior surface microfilm buildup
- Niche environments for detoxification

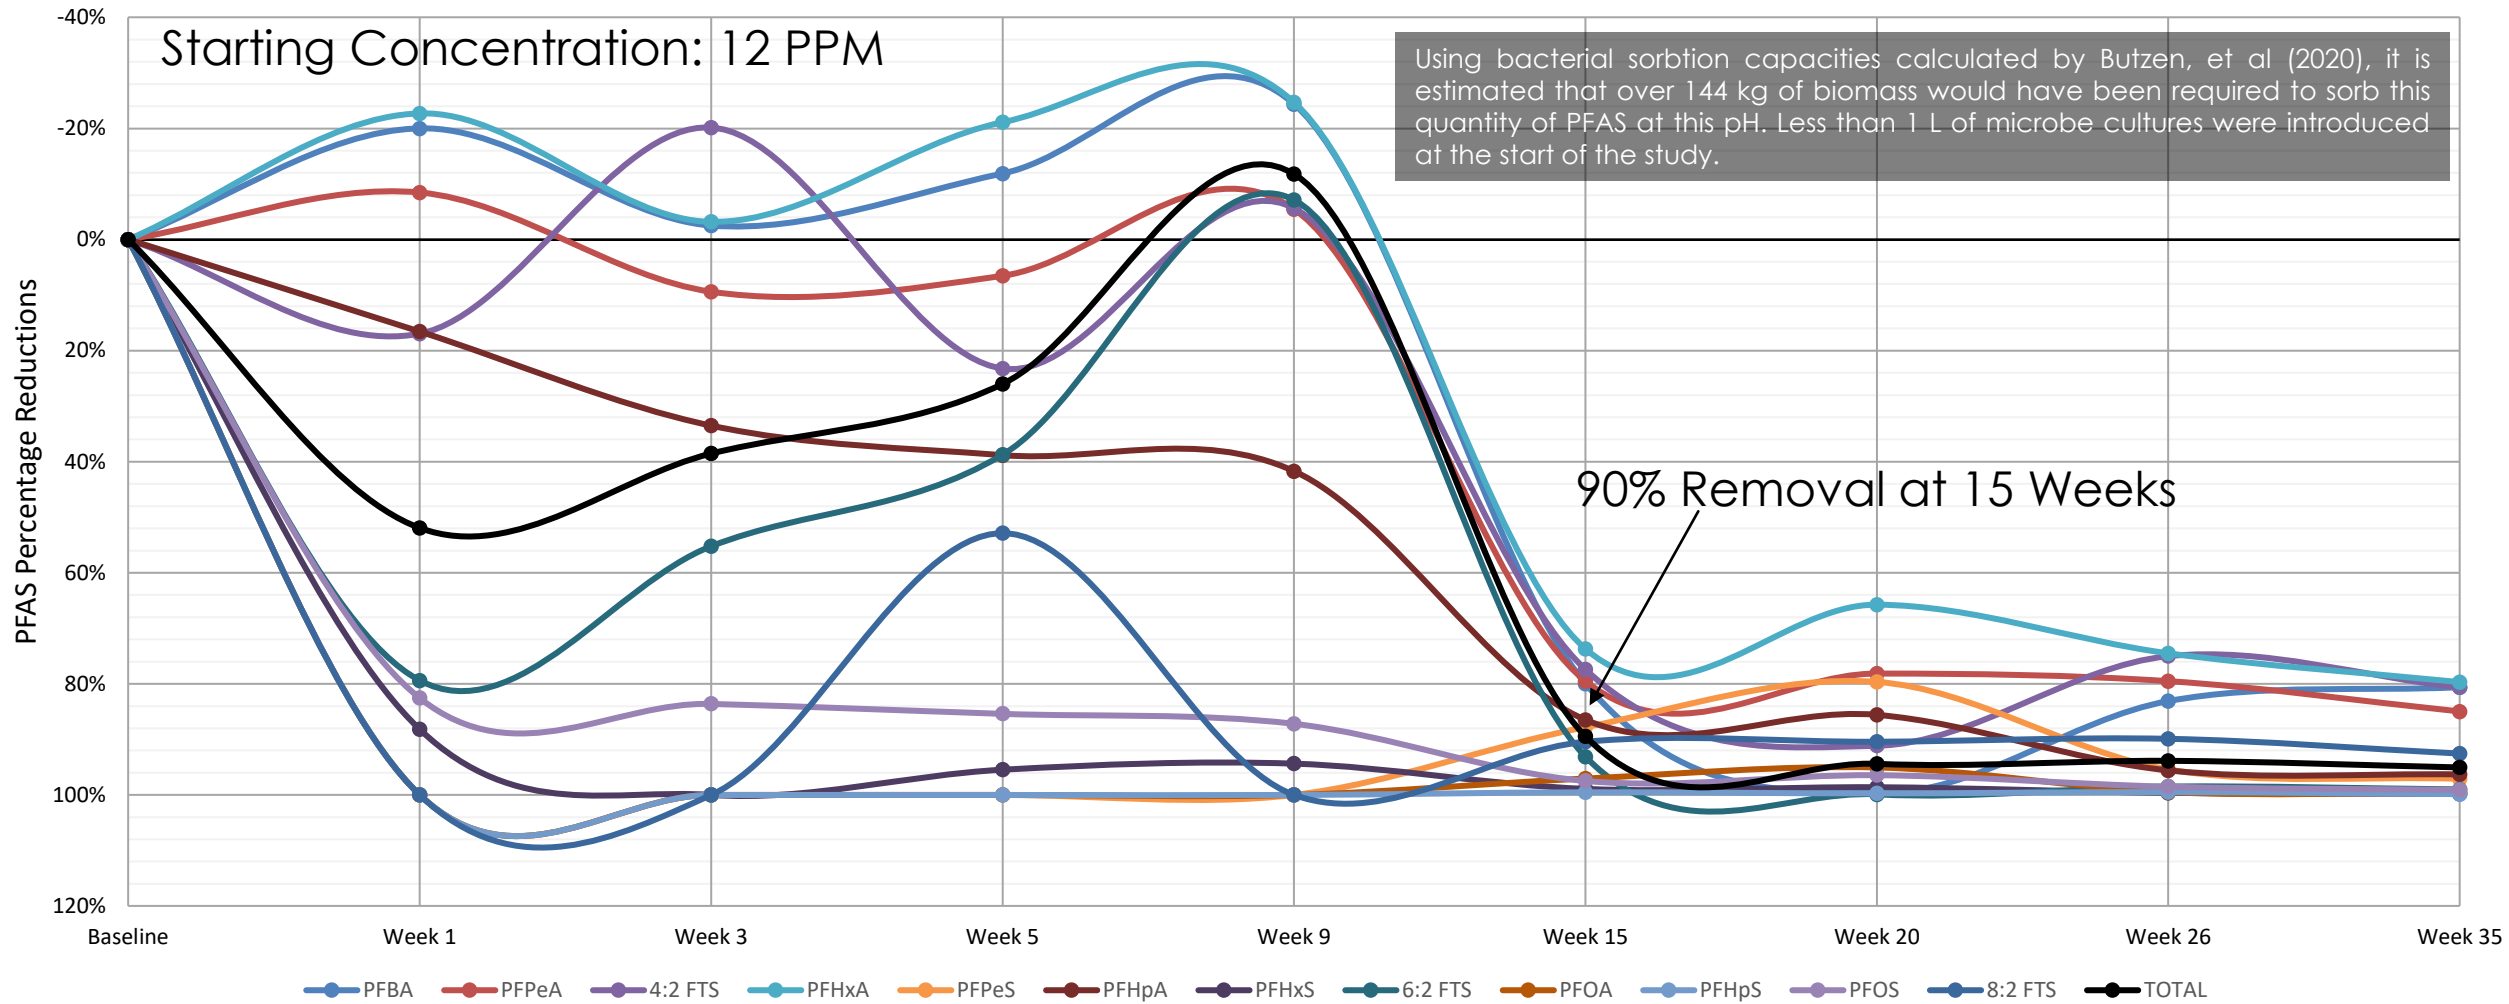
# Tote 2 - PFAS Degrading Bacteria Alone

## TOTE 2 – MICROBES ONLY – PERCENT REMOVAL

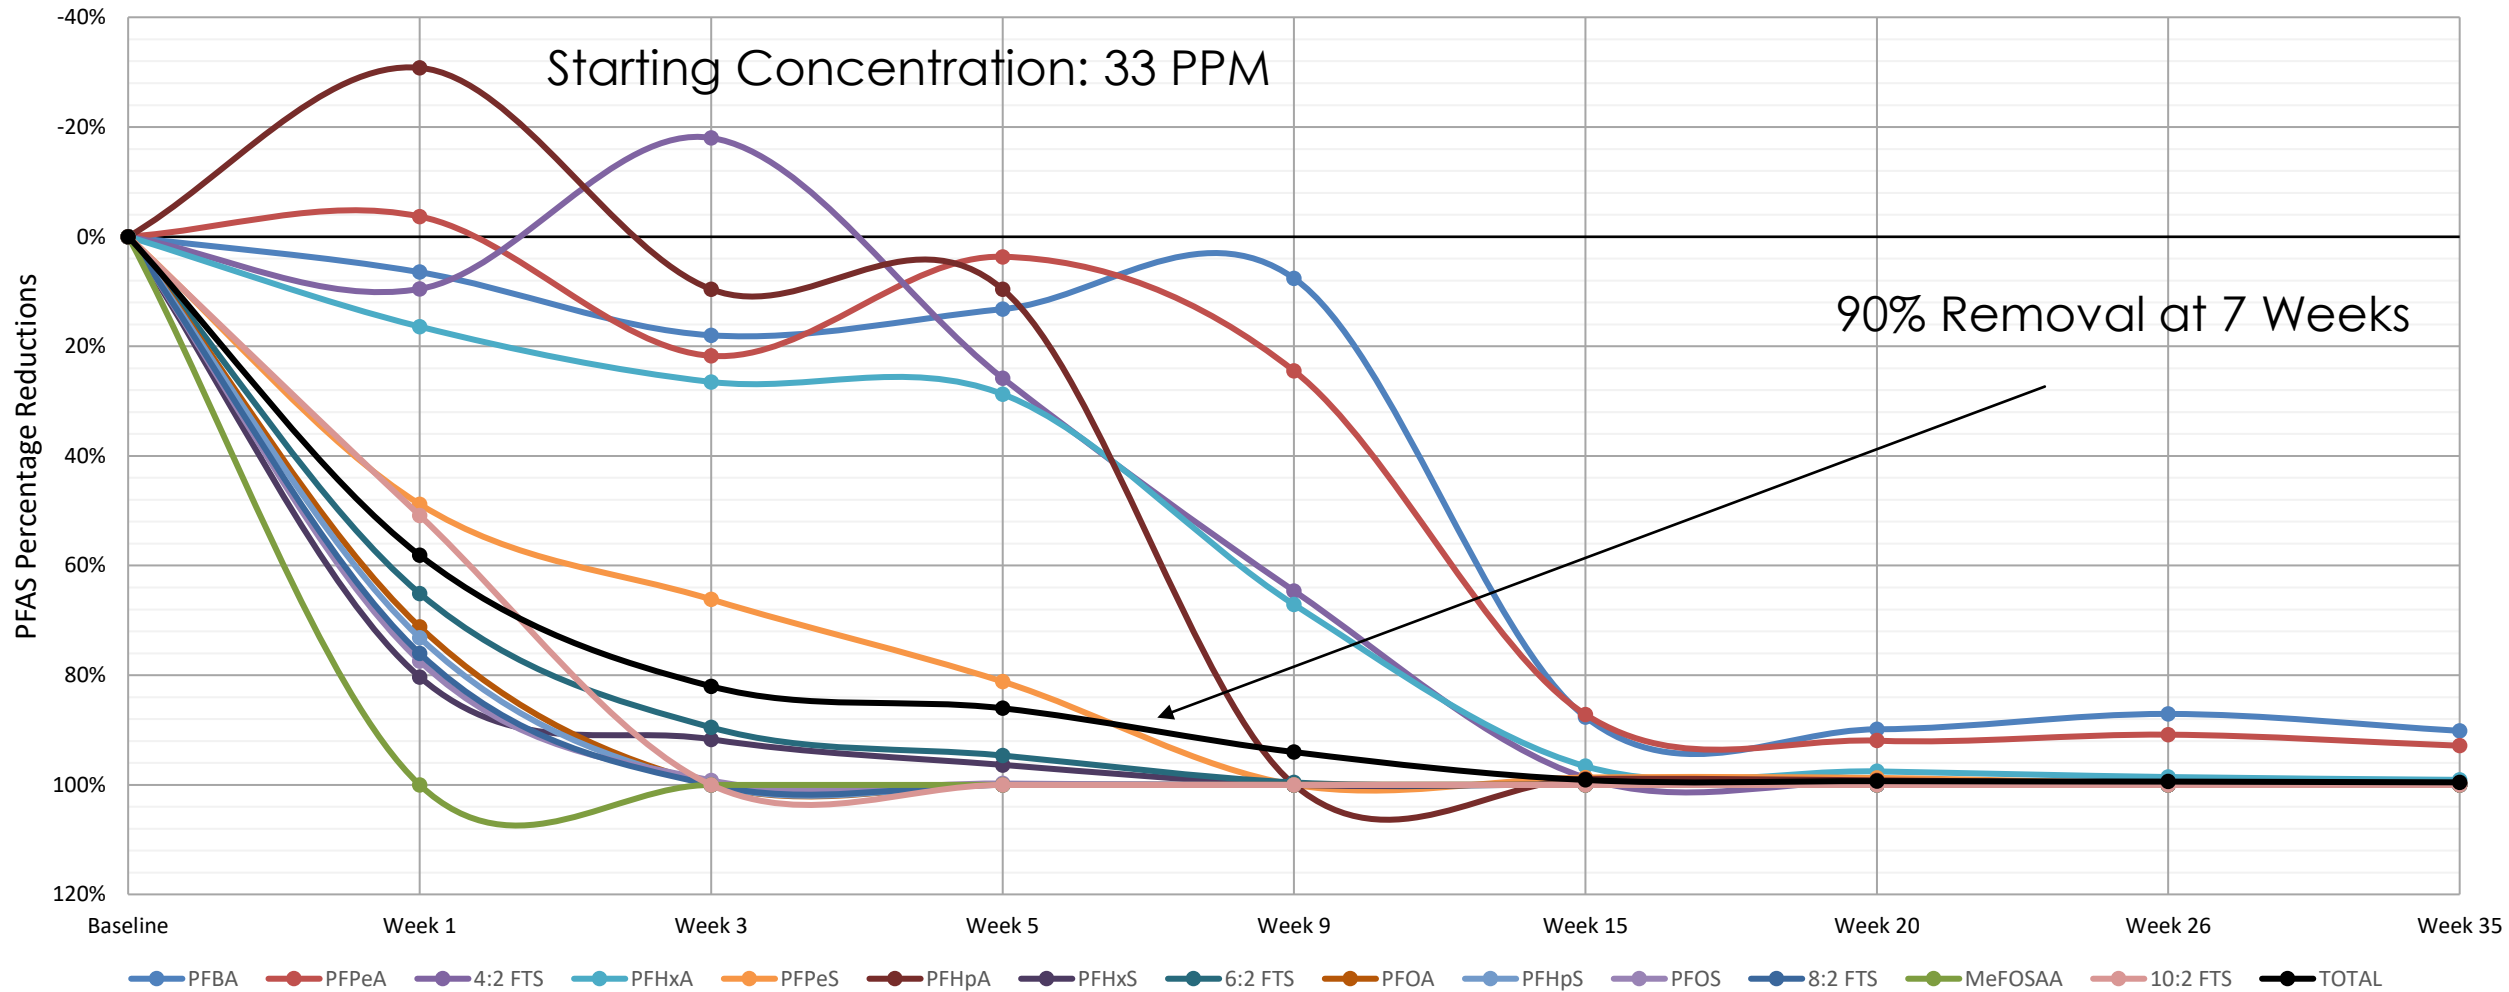
# Tote 1 - BAM Ultra with PFAS Degrading Bacteria

## TOTE 1 – BAM AND MICROBES – PERCENT REMOVAL

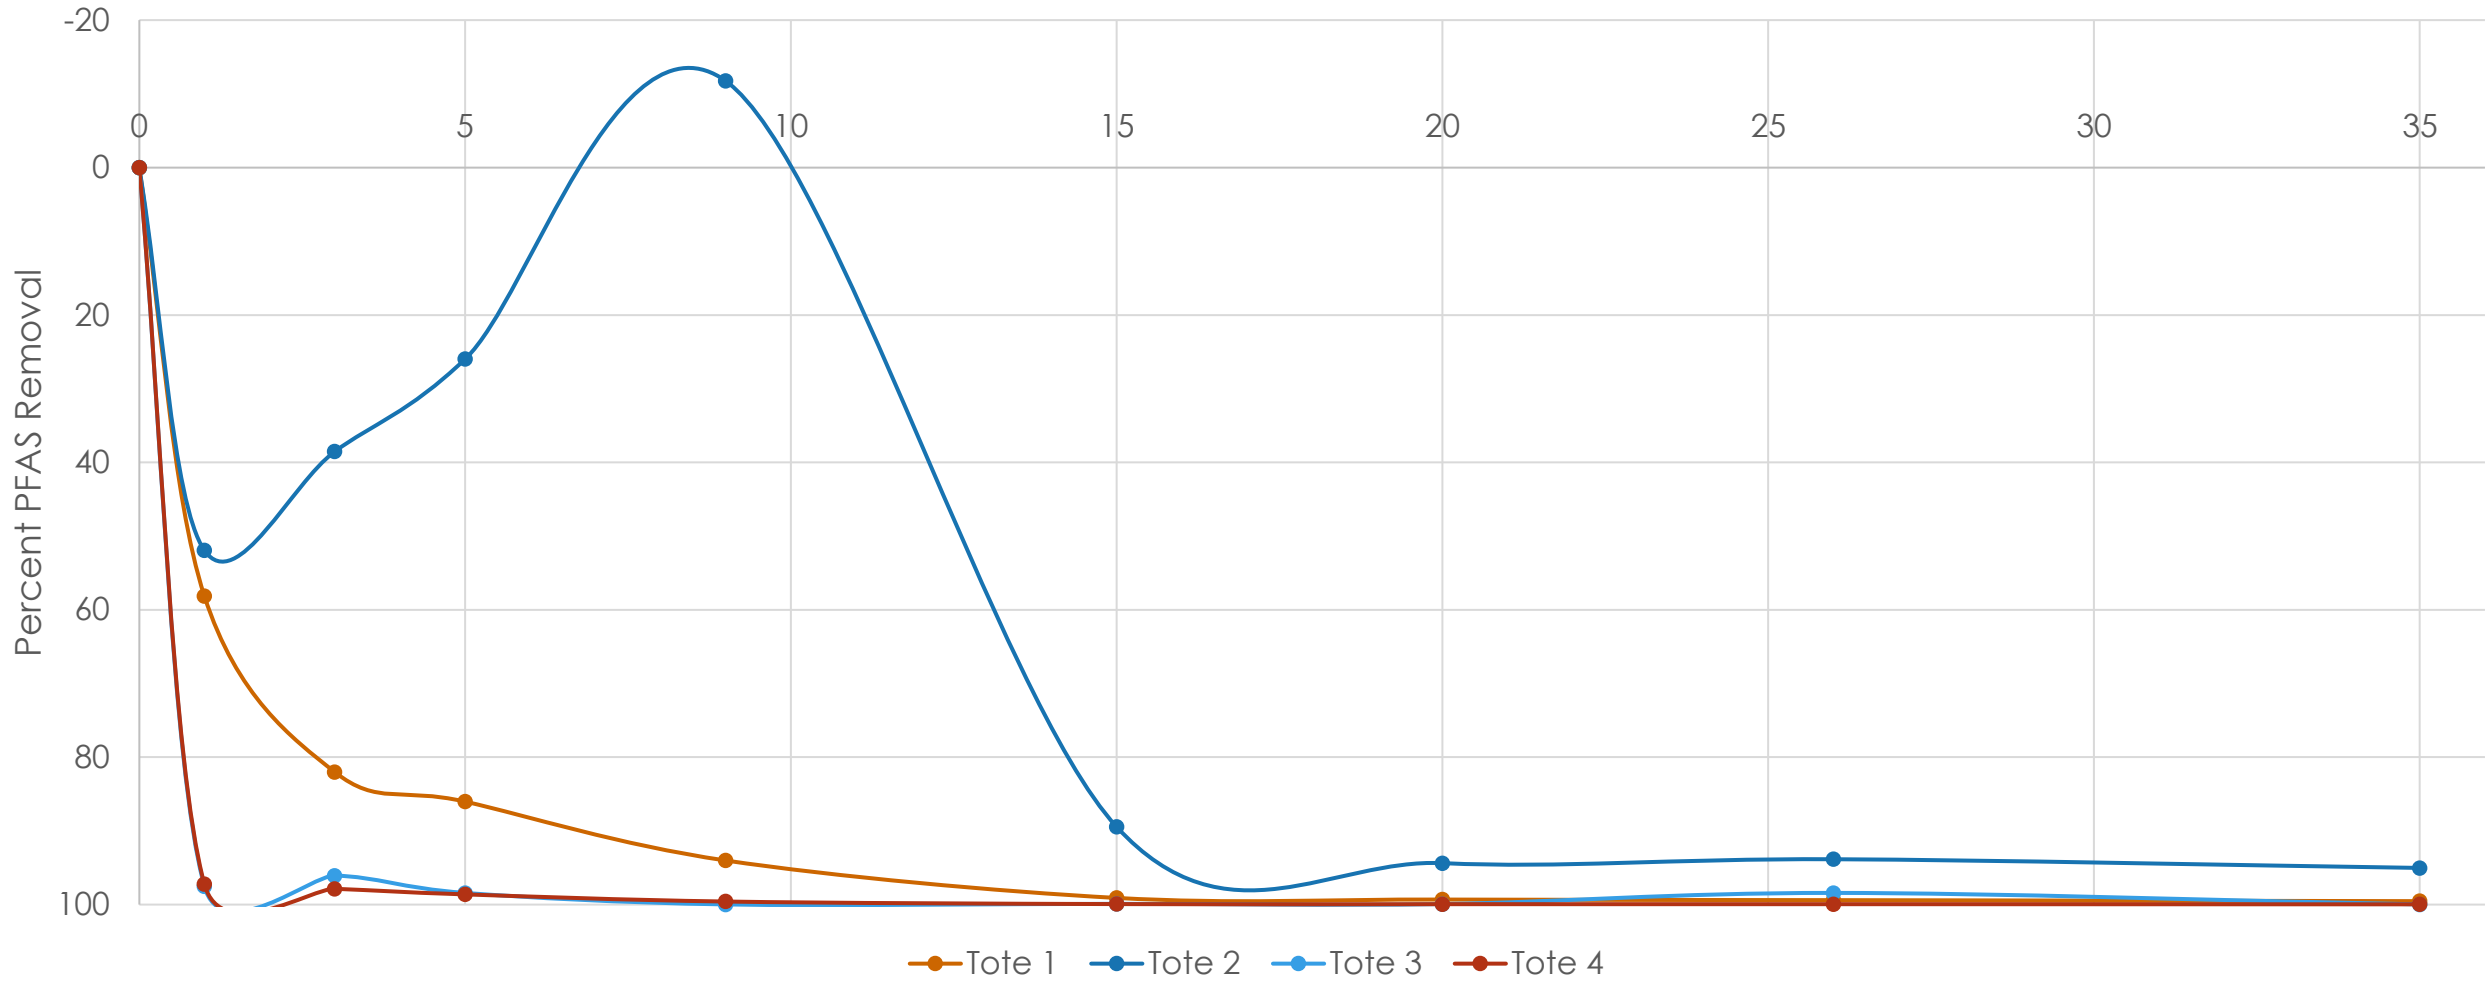
# Total PFAS Removal Summary Data

# Totes Total PFAS SUMMARY Data

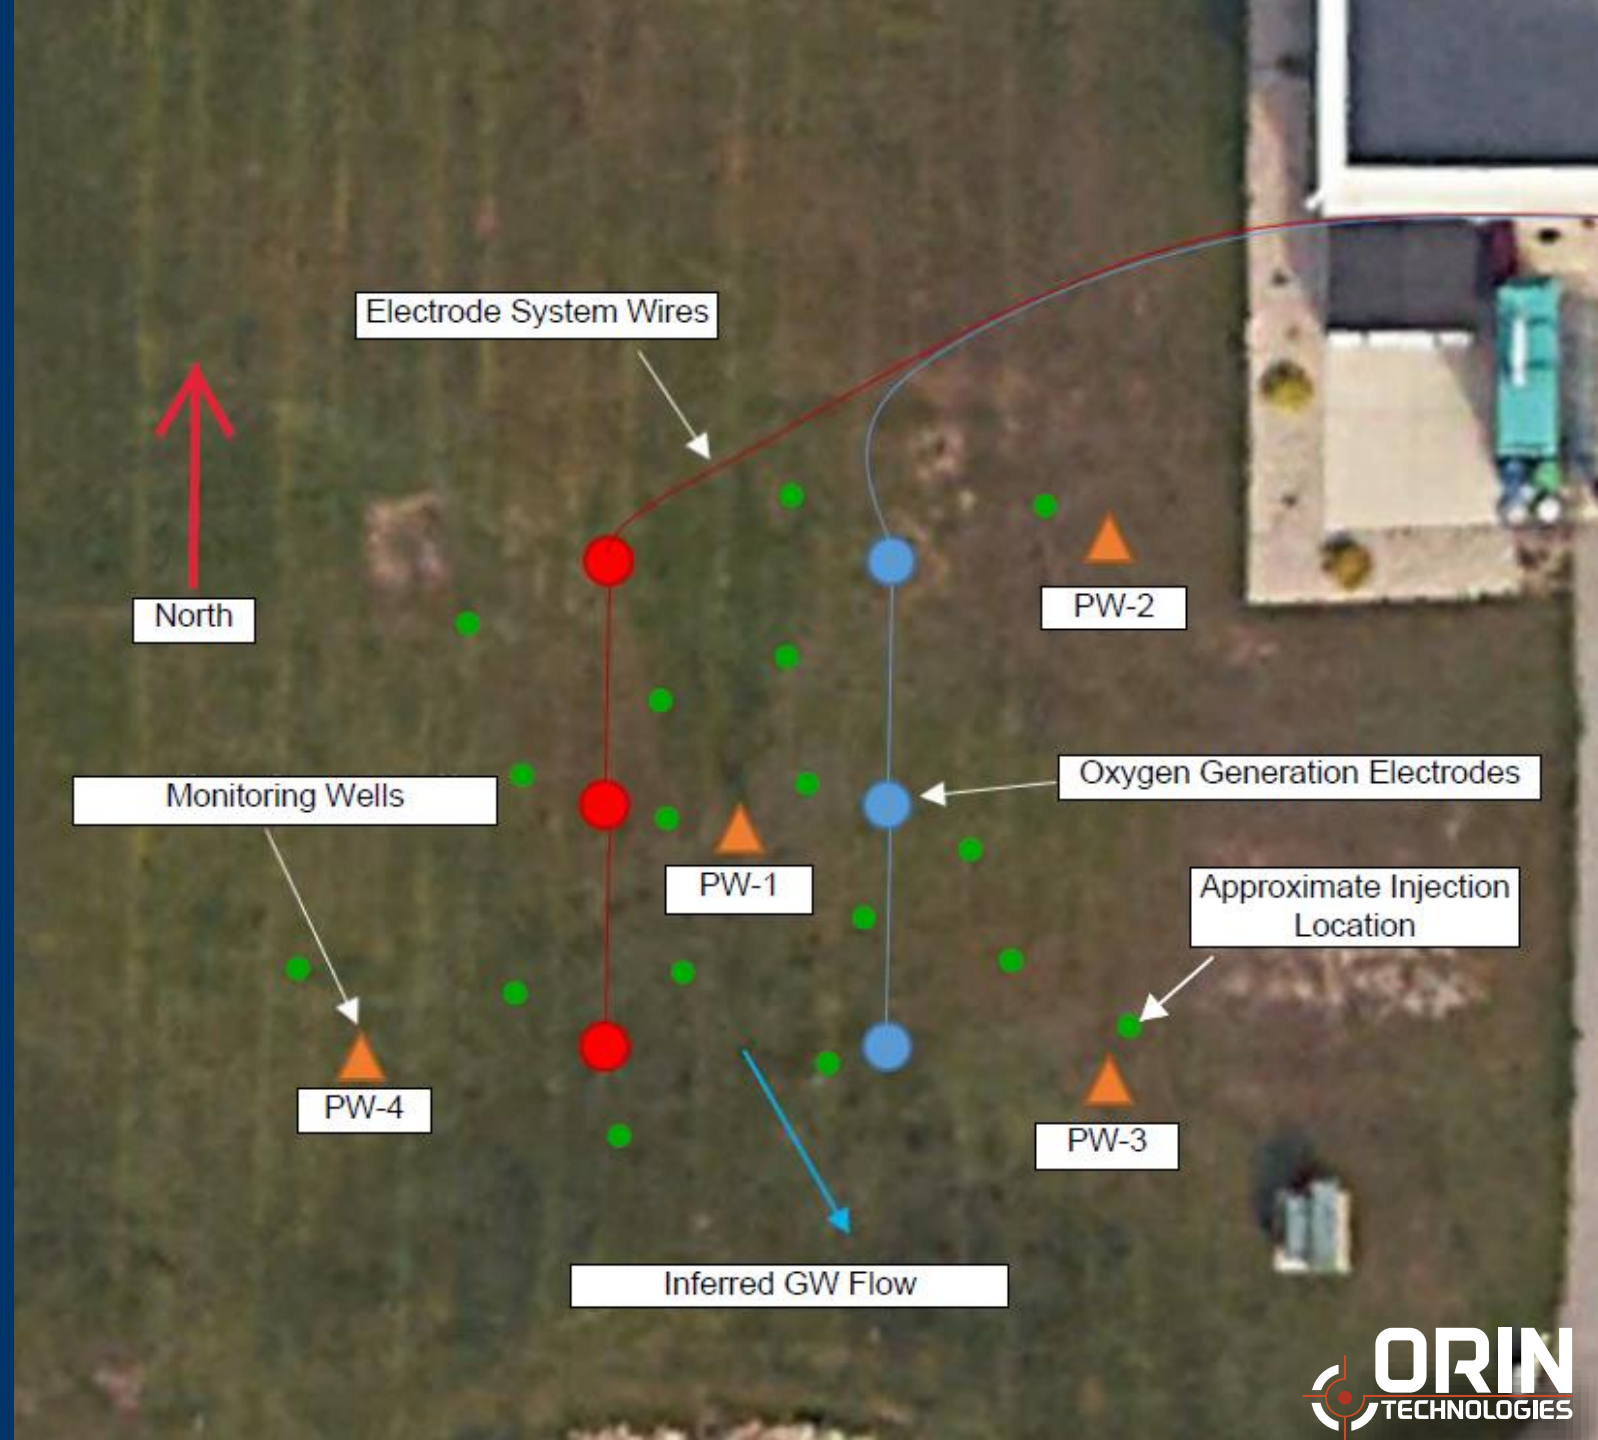
# SITE CONFIGURATION

- Two weeks following the injection an electrokinetic unit was installed to maintain elevated dissolved oxygen in the treatment area.
- 10-16 volts are utilized, electrodes and wires are flush with ground, minimizing impacts to airport operations.
- Elevated oxygen is observed in PW-1 and PW-3 and has maintained biological activity in these areas.
- PW-2 and PW-4 returned to anaerobic conditions after the initial injection and minimal biological activity has been observed.

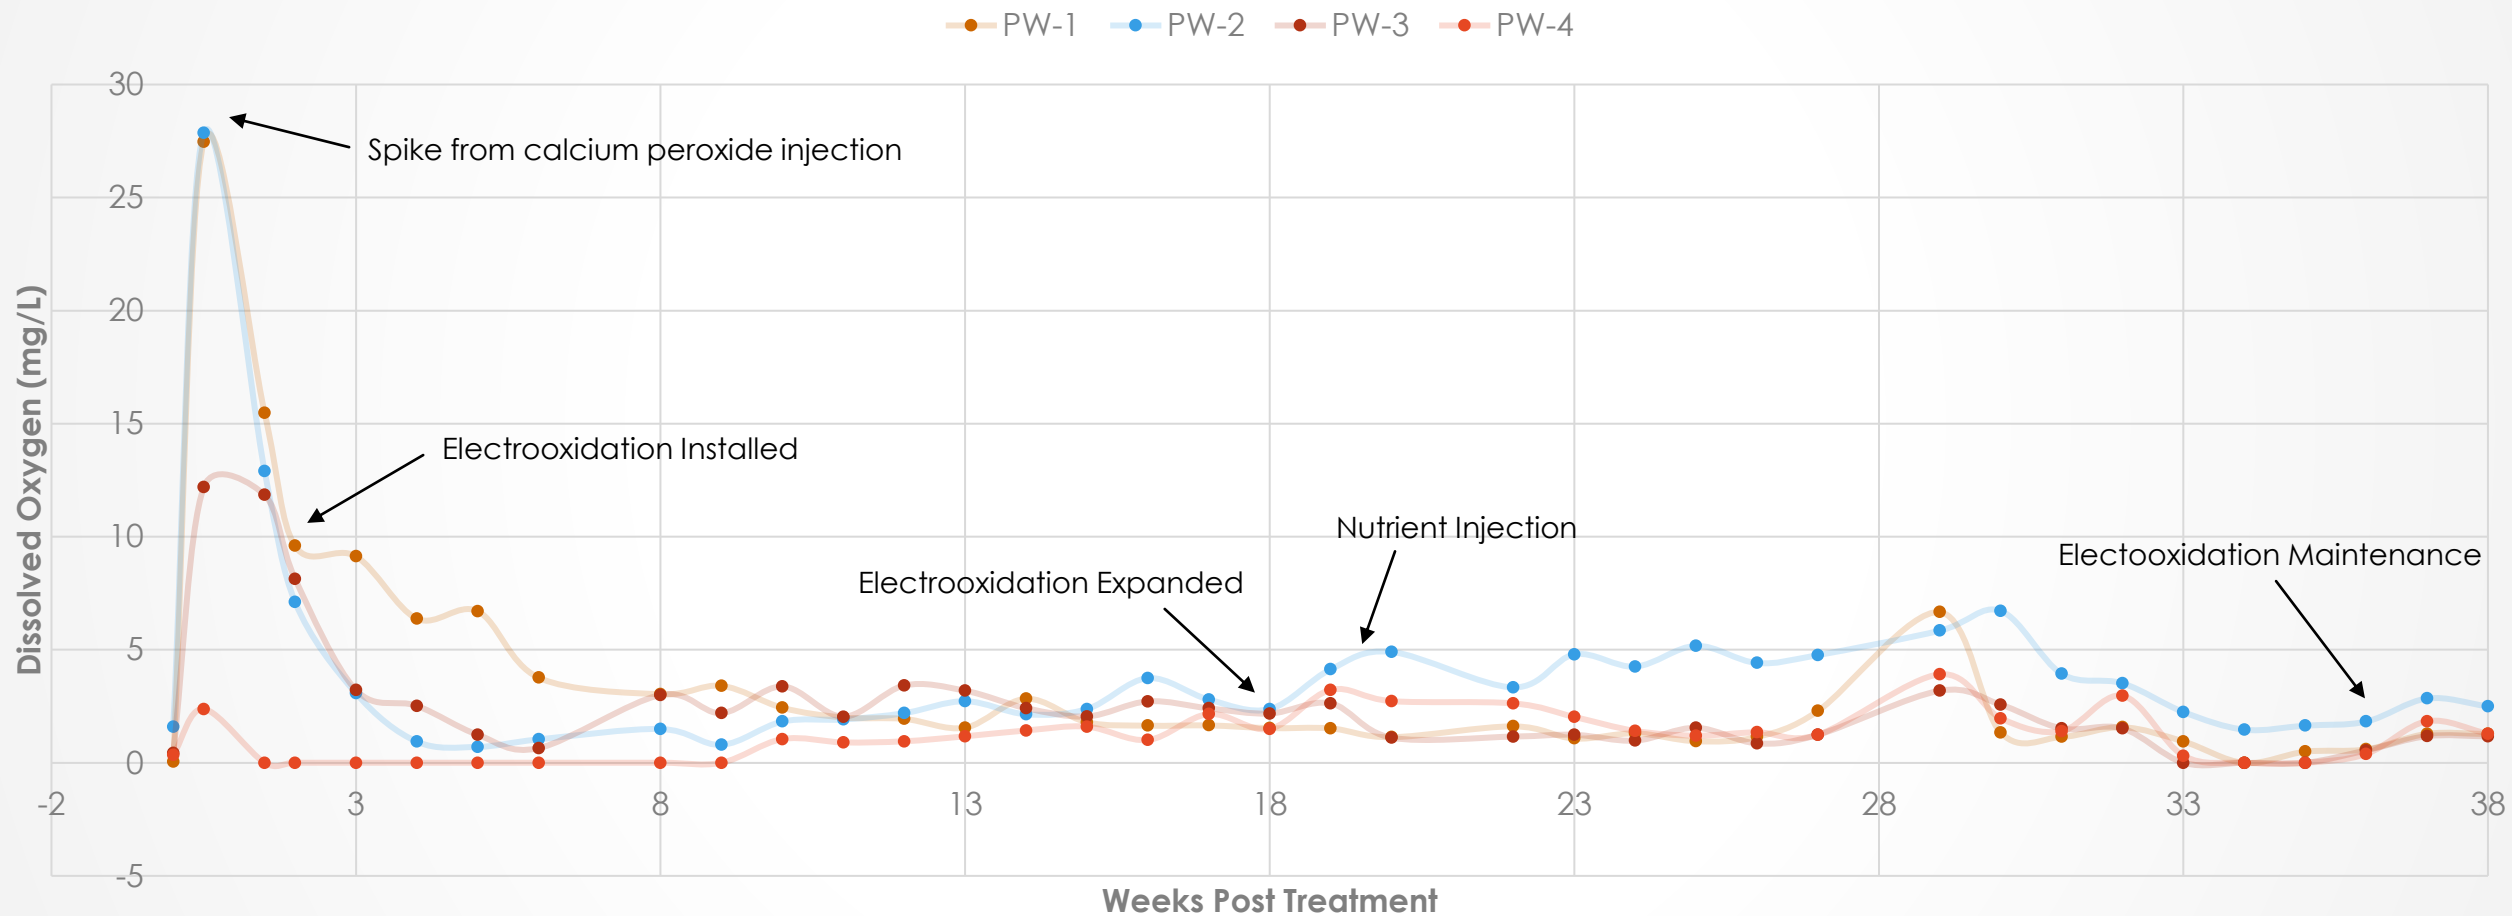
# Dissolved Oxygen Concentrations

## Dissolved Oxygen Monitoring Data

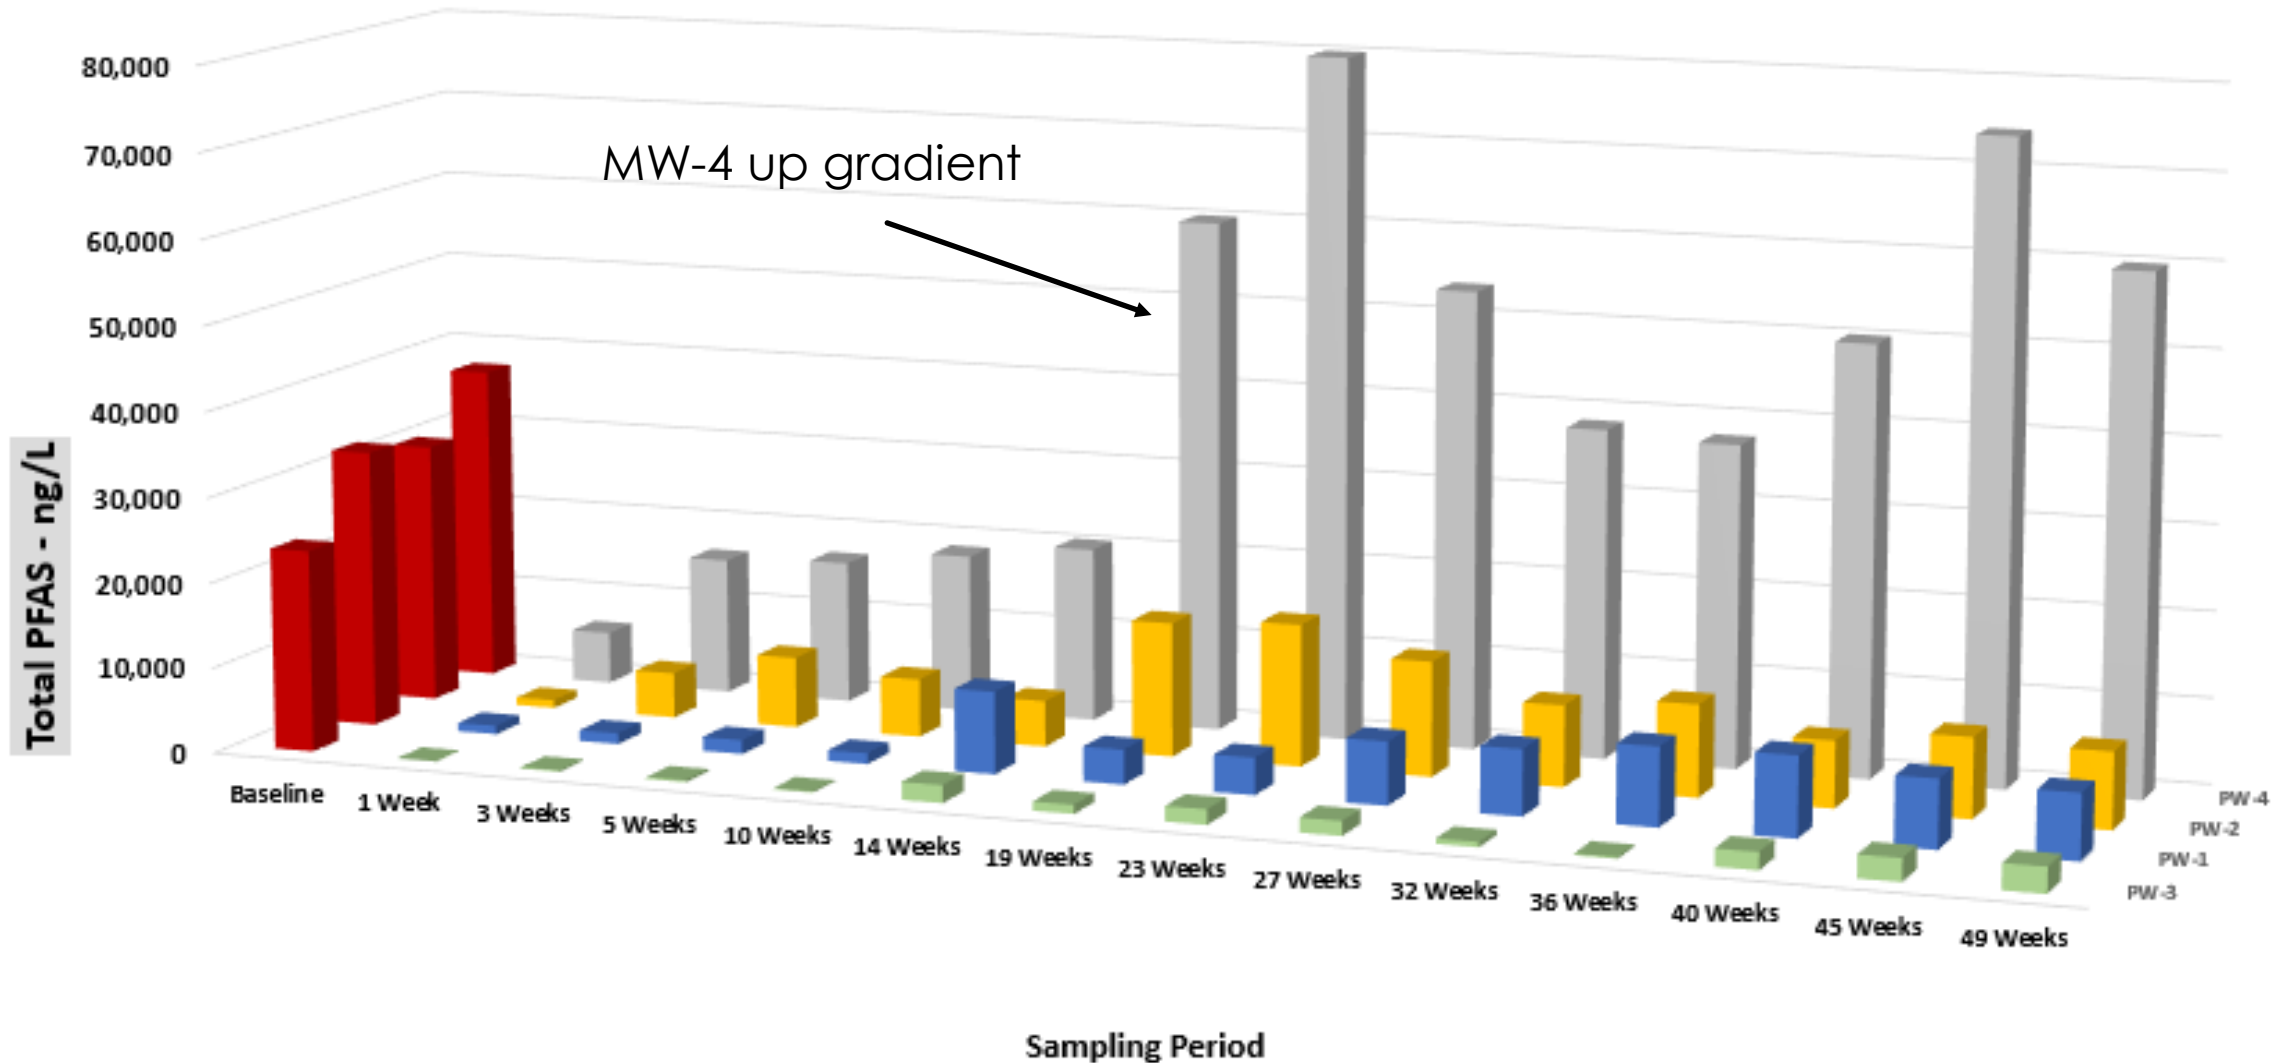
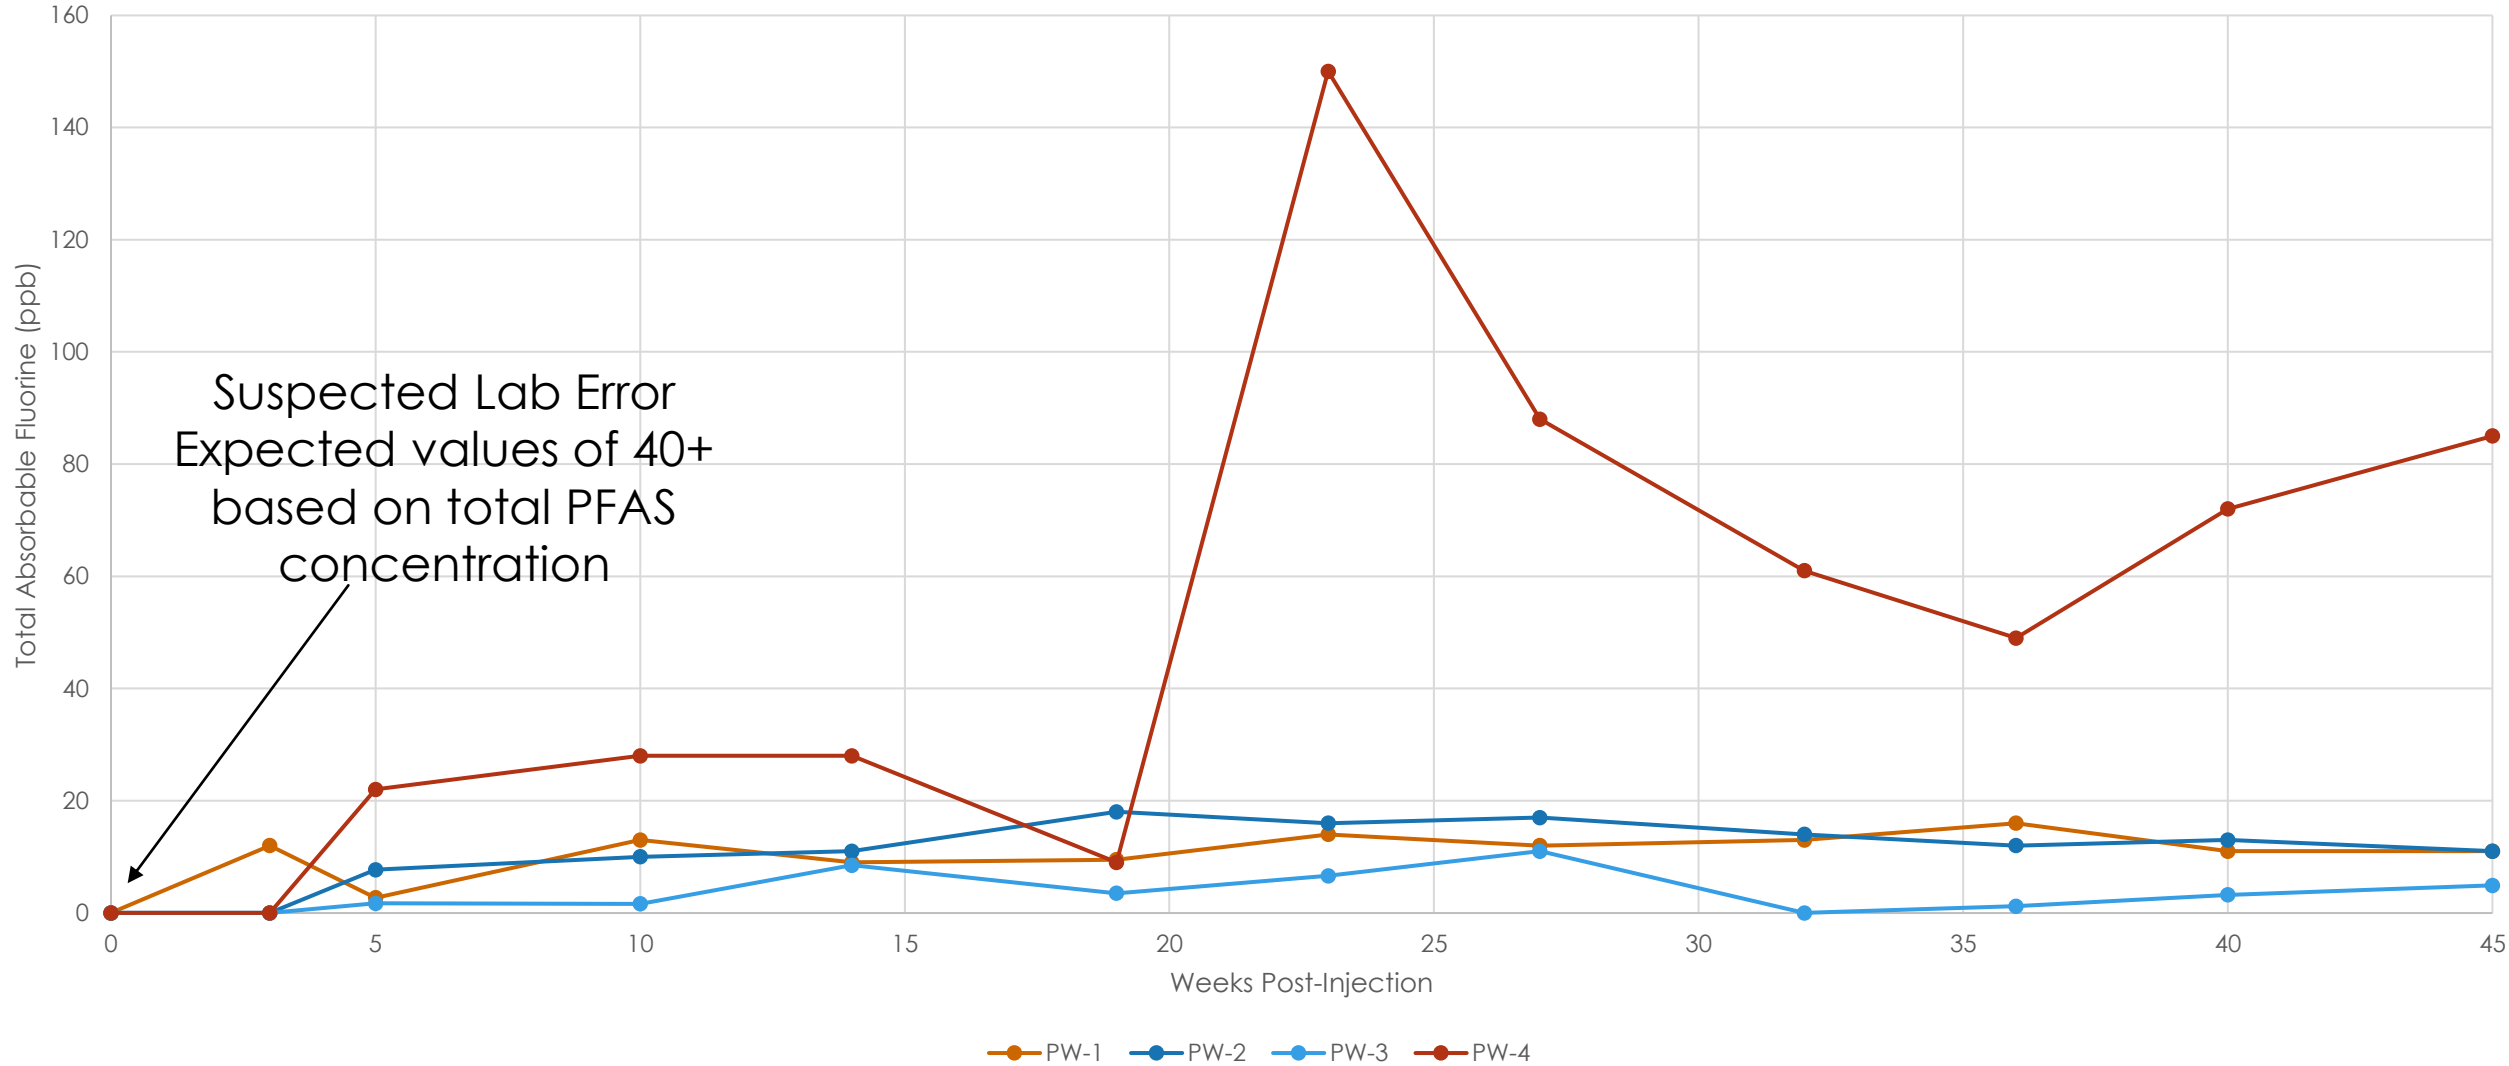
# Groundwater Concentrations

Total PFAS Concentrations in monitoring wells

Suspected Lab Error  
 Expected values of 40+  
 based on total PFAS  
 concentration

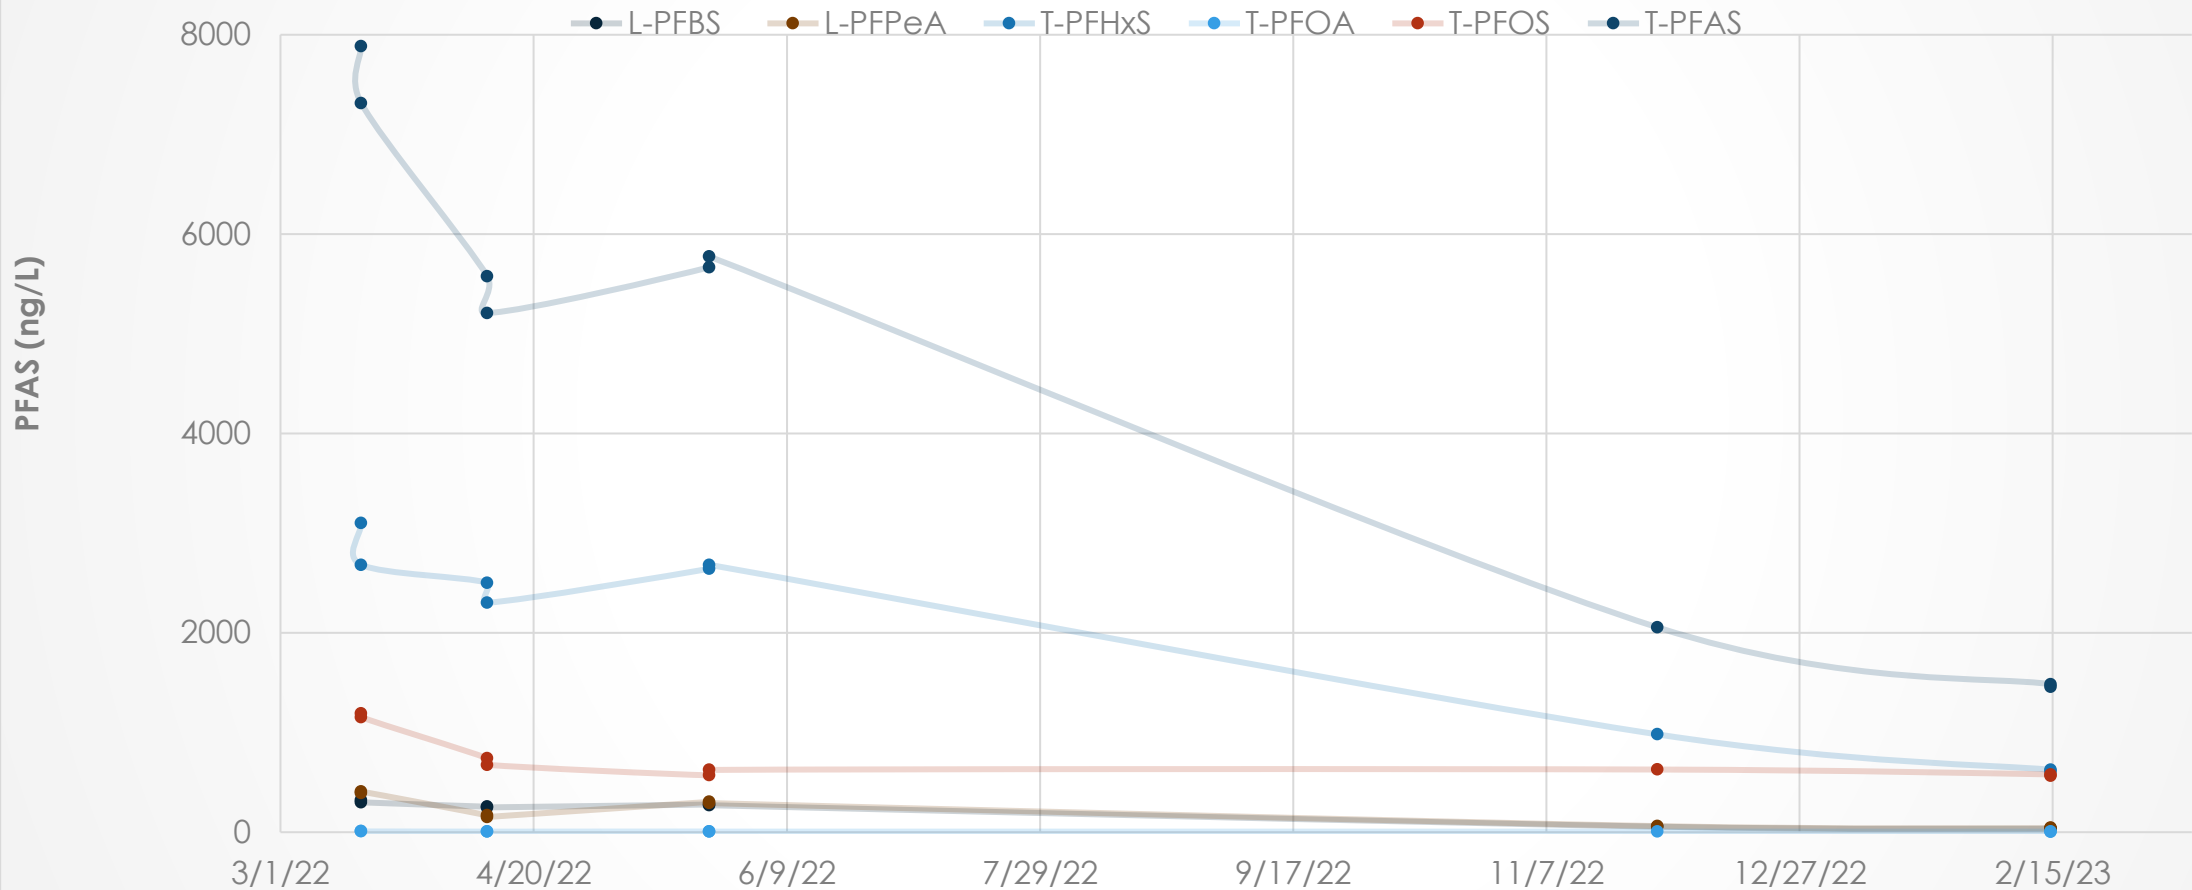
# Groundwater Results

PFAS in Groundwater – Downgradient Well MW-T4

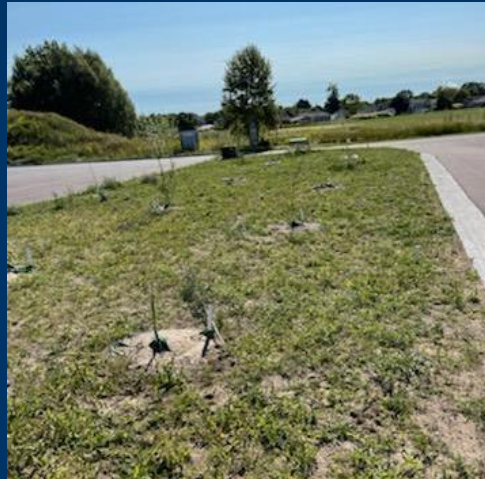
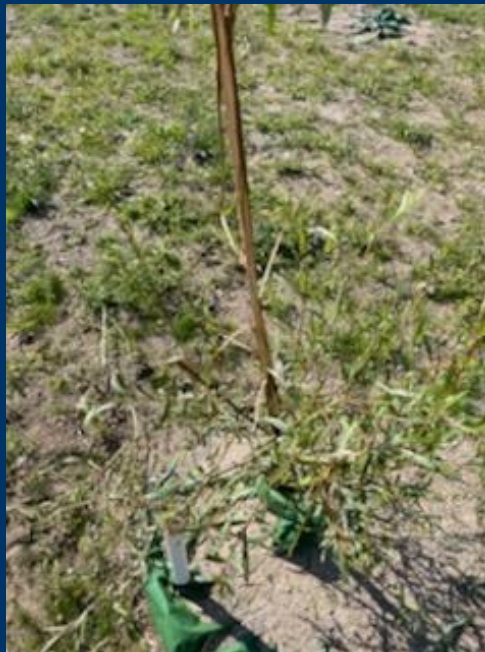
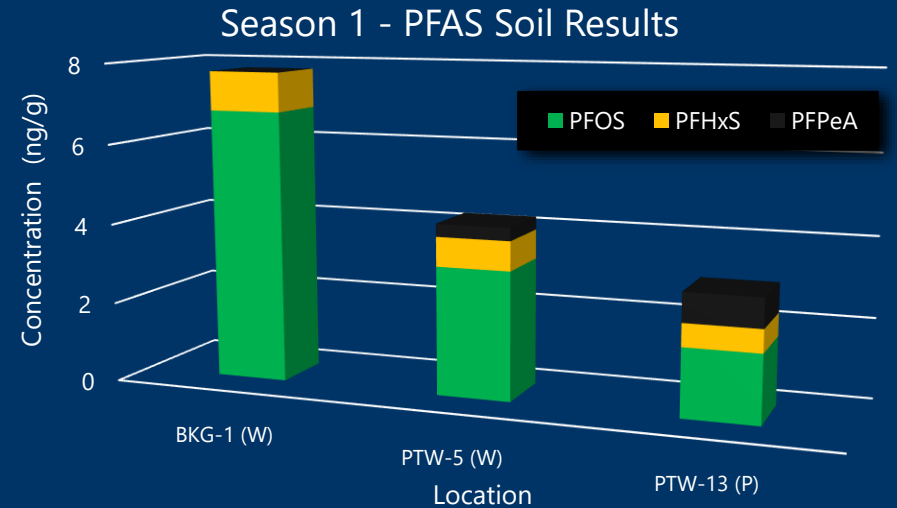
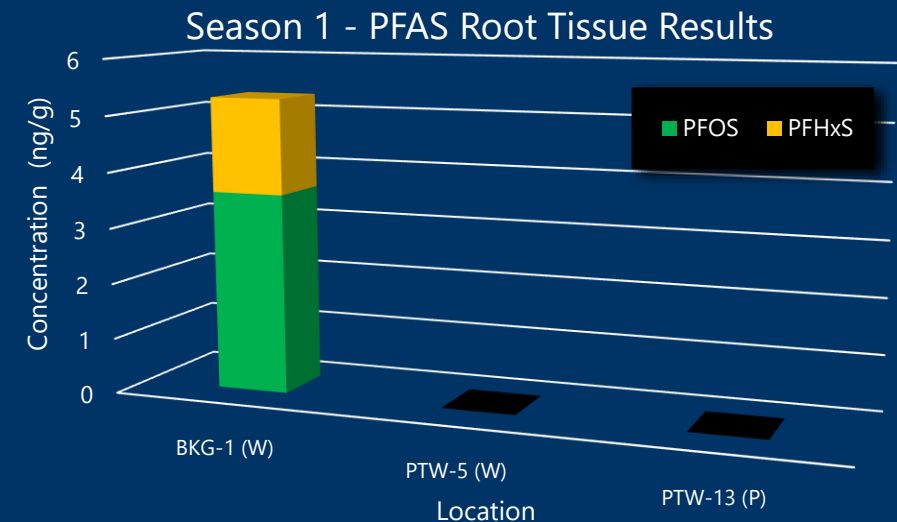
# Tree uptake – Roots and Soil Results

- September 2022 – BUCK!
- Two trees were killed and required replacement (i.e., root testing)
- Wild and free willows (~2-3 yrs in age) used for background
- Background tree detected PFOS > PFHxS in soil and root tissue
- BAM™ treated soils detected PFOS > PFHxS ~ PFPeA
- No PFAS detected in treated roots

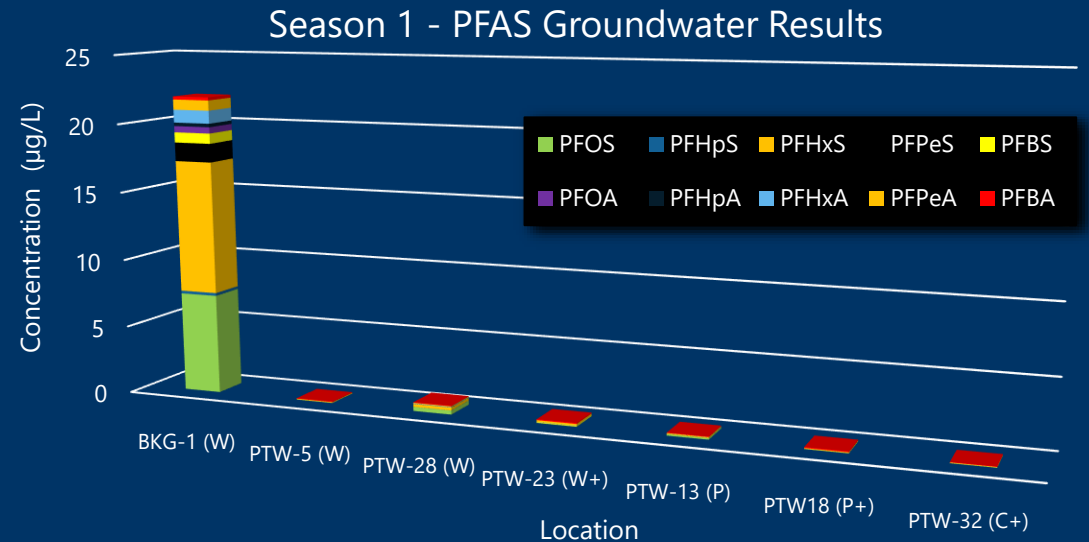
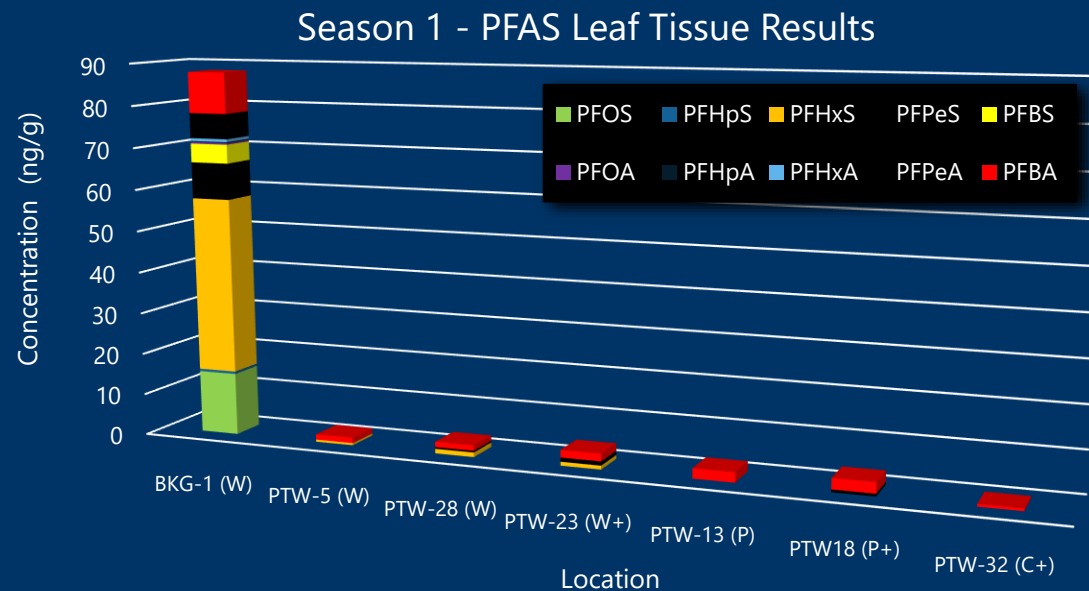
# Tree uptake – Leaves and Groundwater Results

- Piezometers used to collect groundwater samples during plant tissue sample collection
- Full suite of PFAS detected near background tree location sample location
- Background leaf samples shows attenuation of PFOS (long chains) but amplification of PFHxS and shorter chains
- Only PFBA, PFPeA & PFHxS detected in treated leaves
- Treated groundwater and leaf tissue results ~ equilibrium
- No PFAS detected in “dropped” leaves (not depicted)
