# In-Situ Immobilization and Bioremediation of PFAS

Larry Kinsman | ORIN Technologies in conjunction with Miller

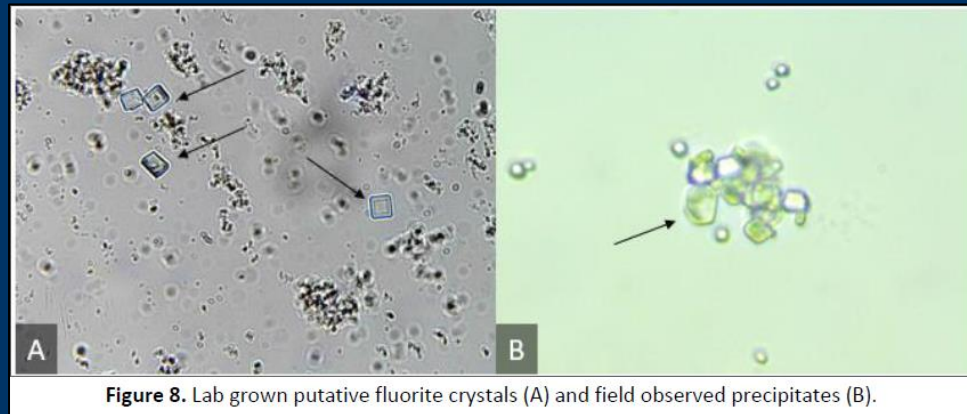
Figure 8. Lab grown putative fluorite crystals (A) and field observed precipitates (B).
